Technical Paper:

Electric Arc Furnace (EAF) Explosions: A Deadly but Preventable Problem

By Scott Ferguson and Nick Zsamboky, Systems Spray-Cooled™

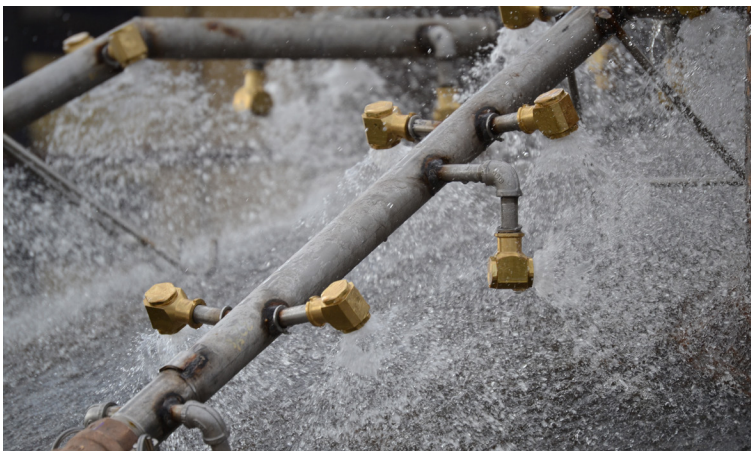
Spray bars in a non-pressurized spray cooling system

The spray system is an arrangement of non-corrosive piping and spray nozzles which are removable using detachable spray bars that connect to a water supply header with cam locks. A single inlet feeds the header. The entire piping network is attached to the outer shell so that the hot plate may be replaced without affecting the spray system. Cooling capacity can be readily changed by adjusting the amount of water distributed in a particular area of the equipment. This is determined by the size and quantity of the nozzles used.

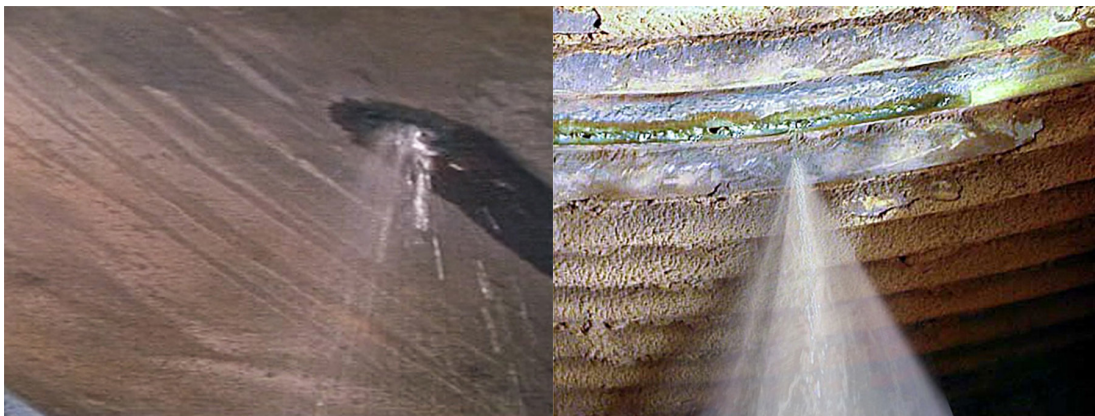
Leak in a non-pressurized spray cooling system (left) vs. leak in a pressurized tubular system (5 gal/hr vs. 16,000 gal/hr)

With non-pressurized spray cooling, equipment operates at a roughly 30 psi cooling water supply pressure at the nozzle heads; however, when the water leaves the spray system it is at atmospheric pressure, as compared to typically 60 psi for pressurized tubular equipment. The significance is that, in the event of a crack or leak, spray cooling will not force high volumes of water into the furnace as a pressurized tubular system does. For a comparable cooling supply flow rate, tubular equipment will introduce over 3,000 times more water into a furnace than a spray cooling system.

For example, a two square-inch hole in a tubular panel operating at 60 psi will force approximately 16,000 gallons per hour into the furnace. By comparison, the same two square-inch hole in the spray cooling practice will introduce less than five gallons into the furnace in the same hour. Looking at it during a one-minute time span, the tubular panel will force 266 gallons per minute into the furnace whereas spray cooling will introduce less than eleven ounces per minute. This greatly reduces the risk of dangerous and possibly deadly steam explosions. In minimizing the chance of excess water entering the furnace, it thereby addresses the root cause of EAF accidents in a proactive and preventive manner.

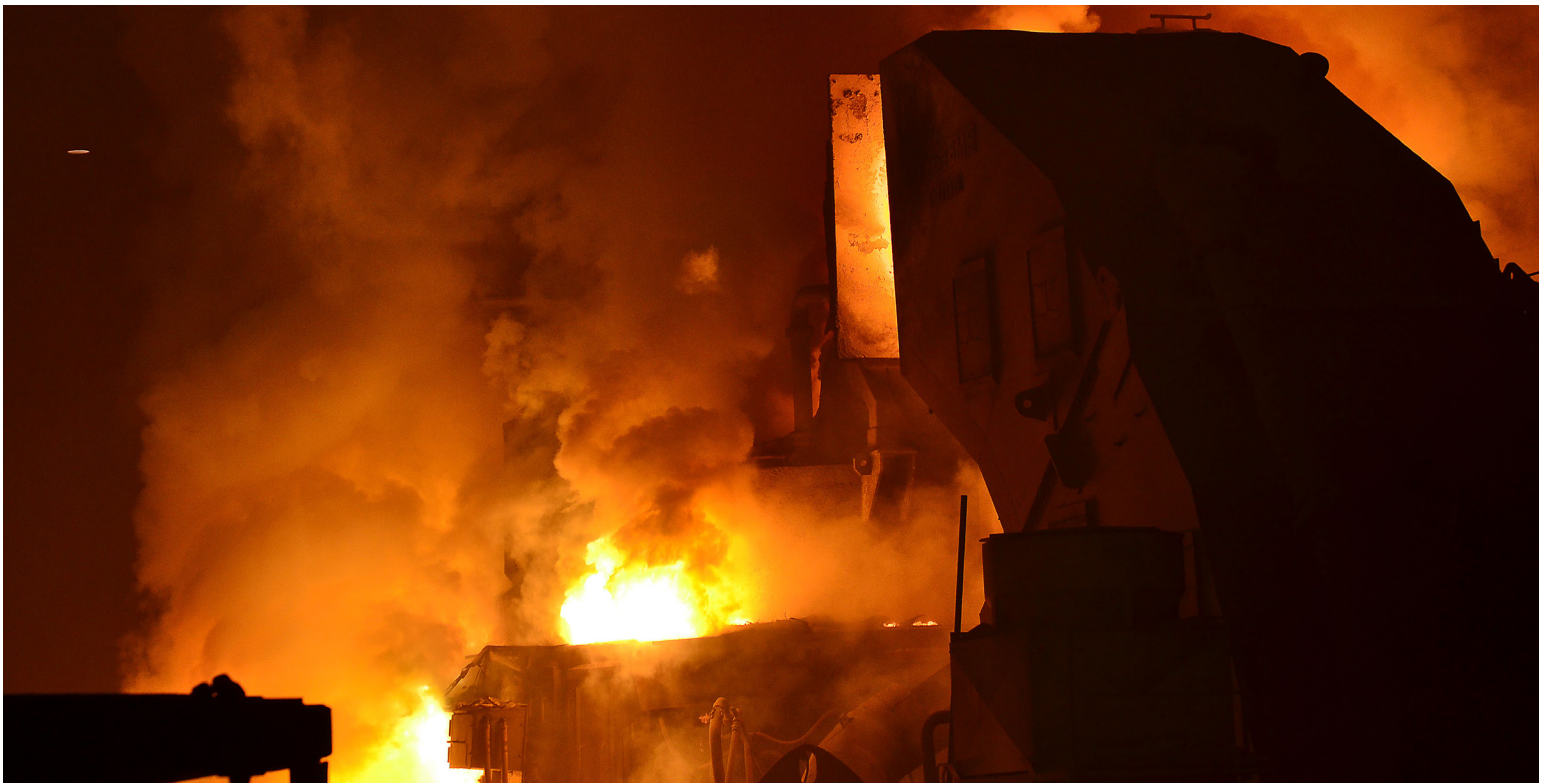
Charging of a 170 Ton EAF
